# Revision of Ceramic Hip Replacements for Fracture of a Ceramic Component

## AAOS Exhibit Selection

*Investigation performed at the Rizzoli Orthopaedic Institute, Bologna, Italy*

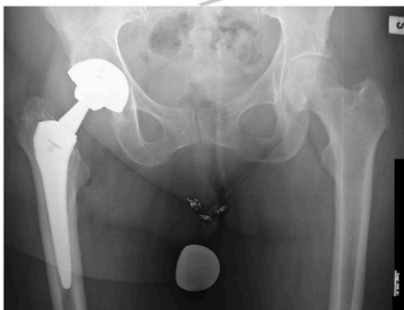
Fig. 1

48-year-old, 18 months after a revision for a ceramic head failure. Painful hip since three months with X-ray and bone scan negative for implant loosening

Early failure of a revision arthroplasty performed because of fracture of a ceramic femoral head.

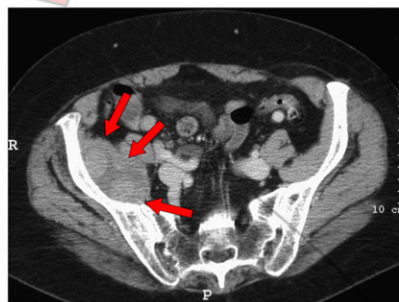
Computed tomography shows intrapelvic mass behind acetabulum

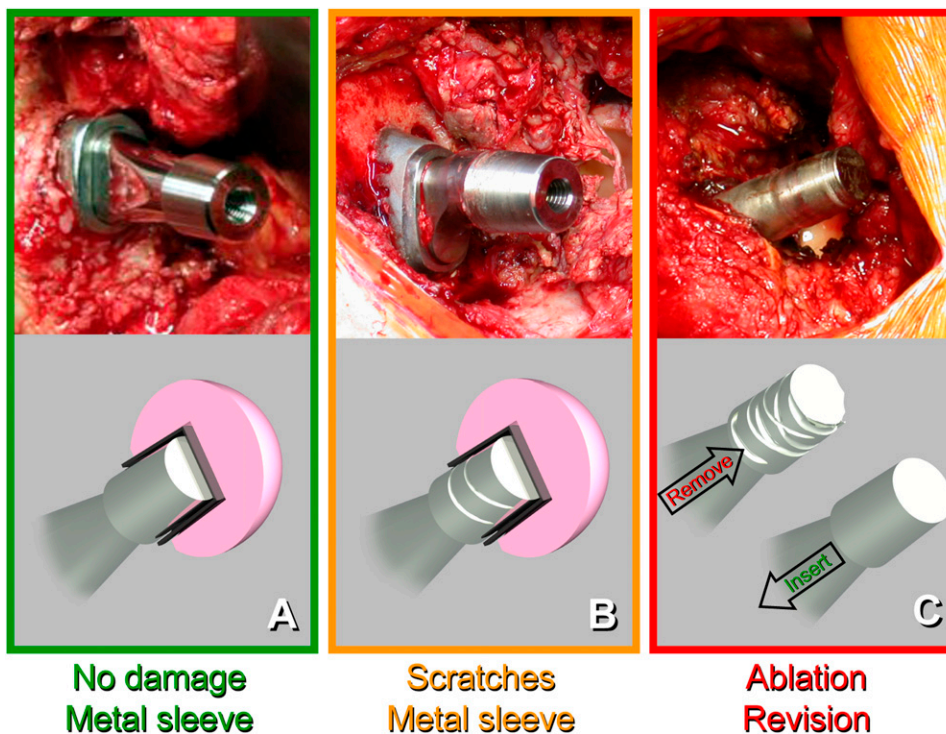
Fig. 2

Evaluation of the neck taper junction of the femoral component and decision-making for revision arthroplasty. A BIOLOX *delta* ceramic head with a metal sleeve can be used if no damage to the neck taper is clearly visible (Fig. 2-A) or if scratches are detected but the shape of the neck taper has not been altered (Fig. 2-B). If ablation or visible abrasion of the surface of the neck taper is visible (Fig. 2-C), revision of the entire femoral component is necessary.

It is preferable to replace the fractured ceramic femoral head with a new ceramic head, since this avoids the abrasive effect of the third-body ceramic particles on the surface (because they have the same hardness as the new femoral head). Ceramic heads designed specifically for revision arthroplasty are available (BIOLOX OPTION; CeramTec); these have a modular design consisting of a BIOLOX *delta* ceramic head and a metal sleeve that can be placed over the original metal neck taper to create a smooth surface. Despite the availability of this implant designed to permit reuse of the femoral stem, the damage to the femoral neck taper must be assessed prior to a decision to use a new ceramic head<sup>10</sup>. If there is gross damage to the femoral neck taper, revision of the entire femoral component is necessary<sup>8,10,11</sup> (Fig. 2).

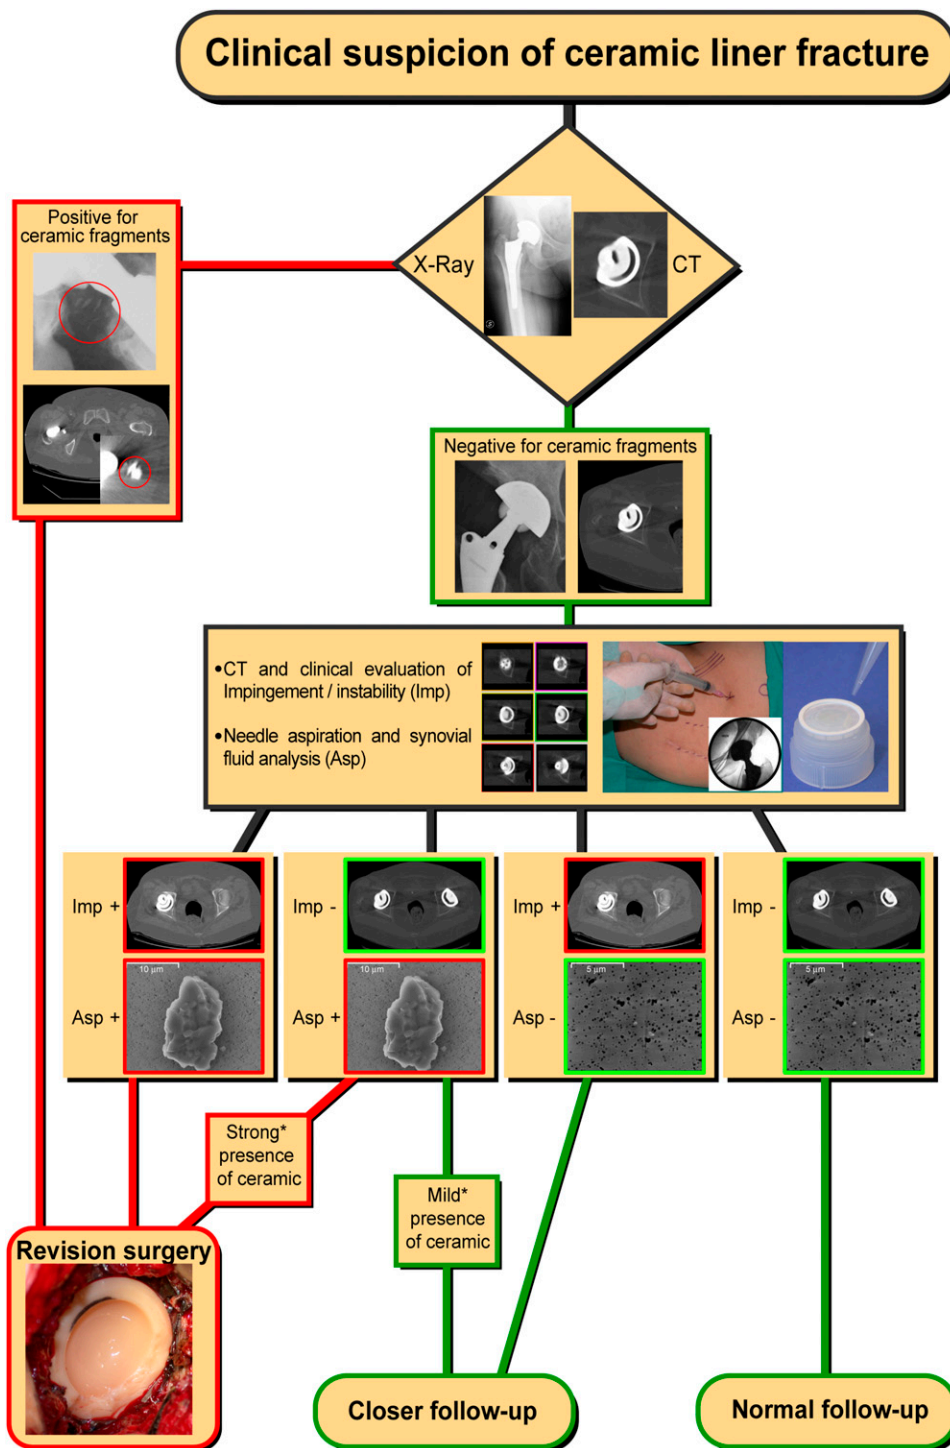
Fig. 3  
Algorithm for diagnosis and treatment of a ceramic liner fracture. CT = computed tomography. \*See Table V.

The onset of a ceramic liner fracture is usually accompanied by subtle clinical signs and could go undetected<sup>13,15</sup>. The first clinical sign reported to the clinician is usually hip noise<sup>12,13</sup>. Computed tomography (CT) scanning of the pelvis and fine needle aspiration of the hip are advisable if a ceramic liner fracture is suspected. If malpositioning of the acetabular component is

observed and ceramic fragments larger than 3  $\mu\text{m}$  are detected in the synovial fluid sample, revision arthroplasty is advisable<sup>12,13,16</sup> (Fig. 3 and Table V).

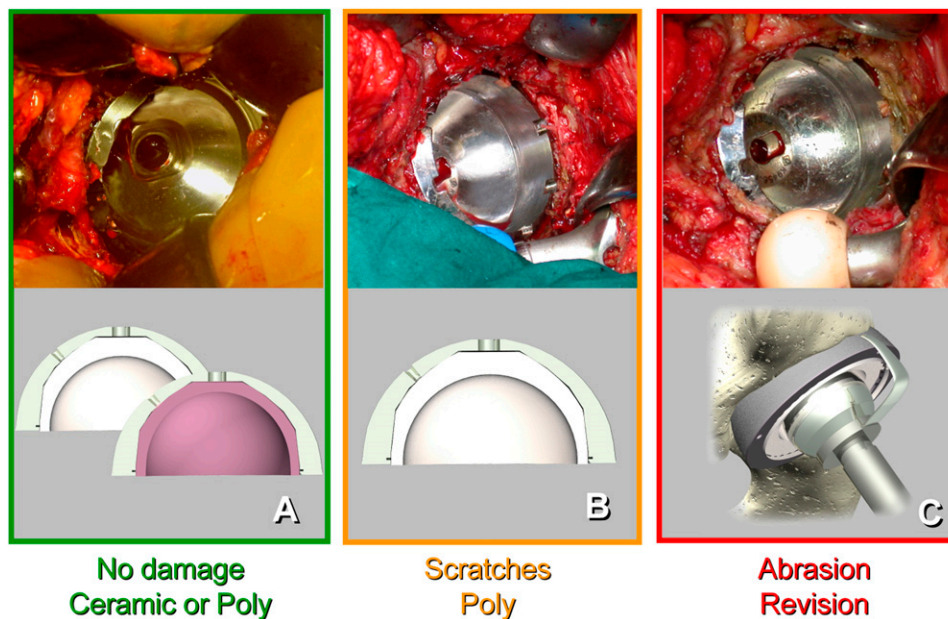
Fig. 4

Evaluation of the taper junction of the metal acetabular shell and decision-making for revision arthroplasty. If no damage to the metal shell is visible (Fig. 4-A), a new BIOLOX *delta* ceramic liner is the best choice but a highly crosslinked polyethylene (poly) liner can also be used. If the metal shell is scratched but without gross damage, a highly crosslinked polyethylene liner is the best choice (Fig. 4-B). If abrasion of the metal shell is visible (Fig. 4-C), revision of the entire acetabular component is necessary.

The liner can be replaced with either a new ceramic liner or a highly crosslinked polyethylene liner; this decision must take into account the damage to the metal shell (Fig. 4) and the stability of the implant. The best choice if a ceramic liner is used is to use a large ceramic head if possible, and the best

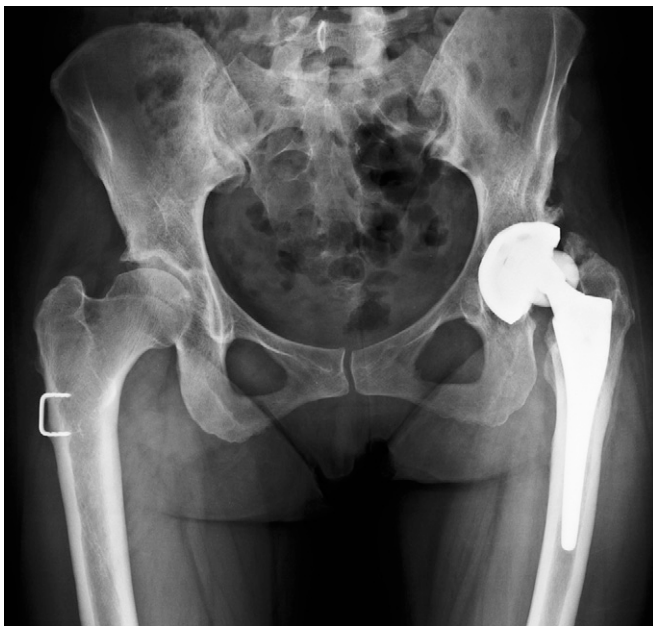
Fig. 5-A

**Fig. 5-A** Anteroposterior radiograph of the pelvis showing excessive abduction of the acetabular cup in a patient who experienced a ceramic liner fracture. **Fig. 5-B** Anteroposterior radiograph of the left hip. After revision of the cup, the bearing surfaces were revised to a new ceramic-on-ceramic articulation. At the time of the latest follow-up, three years after the revision arthroplasty, the implant was stable.

**CASE 1.** This patient was an unemployed fifty-eight-year-old woman (body mass index, 36 kg/m<sup>2</sup>; Charnley class<sup>17</sup> of the hip, A). She experienced repeated dislocations, which were treated conservatively, after the primary total hip arthroplasty. The last dislocation caused a fracture of the ceramic liner resulting in complete functional impairment. The implant instability had been due to malpositioning of the cup (Fig. 5-A). The BIOLOX *forte* ceramic liner had been implanted in a cup with 60° of abduction and 4° of anteversion. The implant offset was 39 mm, the center of rotation of the total hip replacement was 4 mm higher than the anatomic center of rotation, and the involved limb was 5 mm shorter than the contralateral limb. The liner was revised to a BIOLOX *delta* liner, and the femoral head was also revised to a short 36-mm BIOLOX *delta* head. At the time of the latest follow-up, three years after revision
